Article

A Comparison of Beach Nourishment Methodology and Performance at Two Fringing Reef Beaches in Waikiki (Hawaii, USA) and Cadiz (SW Spain)

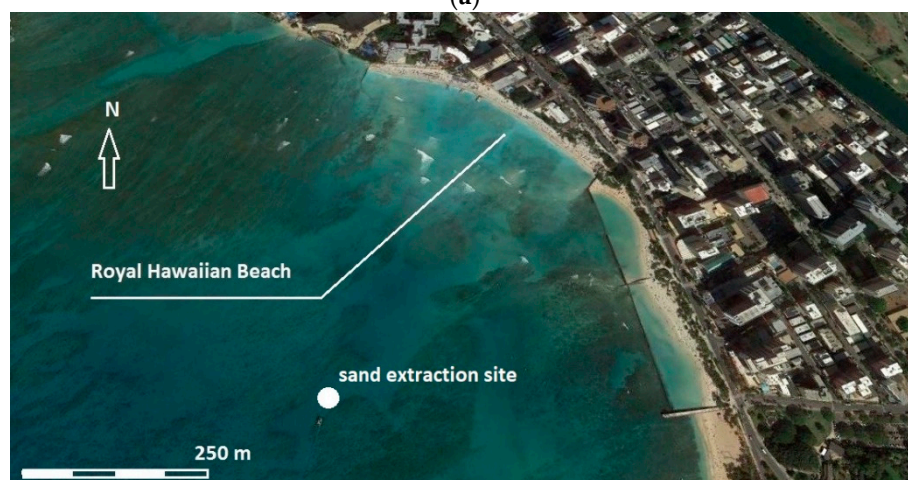
Figure 1. Location of Royal Hawaiian Beach (RHB) in Waikiki, Hawaii, USA (a); and an aerial view where the fringing reef can be observed and the sand extraction site is located (b) (image source: Google Earth 2018).

RHB in Hawaii and VB in Cadiz, SW Spain, are both supported by calcareous reef platforms (Figures 1 and 2, respectively). Beaches on both of these coasts have experienced significant long-term erosion, which is problematic for the nationally important tourism industries that they support. Erosional trends are expected to accelerate with sea level rise [23], which is currently about 6 mm/year in Hawaii [24], and 2–3 mm/year in Cadiz. The costs of adaptation strategies (including beach nourishment) are already being considered [25].
